February 5, 2014

**MEMORANDUM**

**SUBJECT:** Quarterly cap inspection at the San Jacinto River  
Waste Pits superfund site

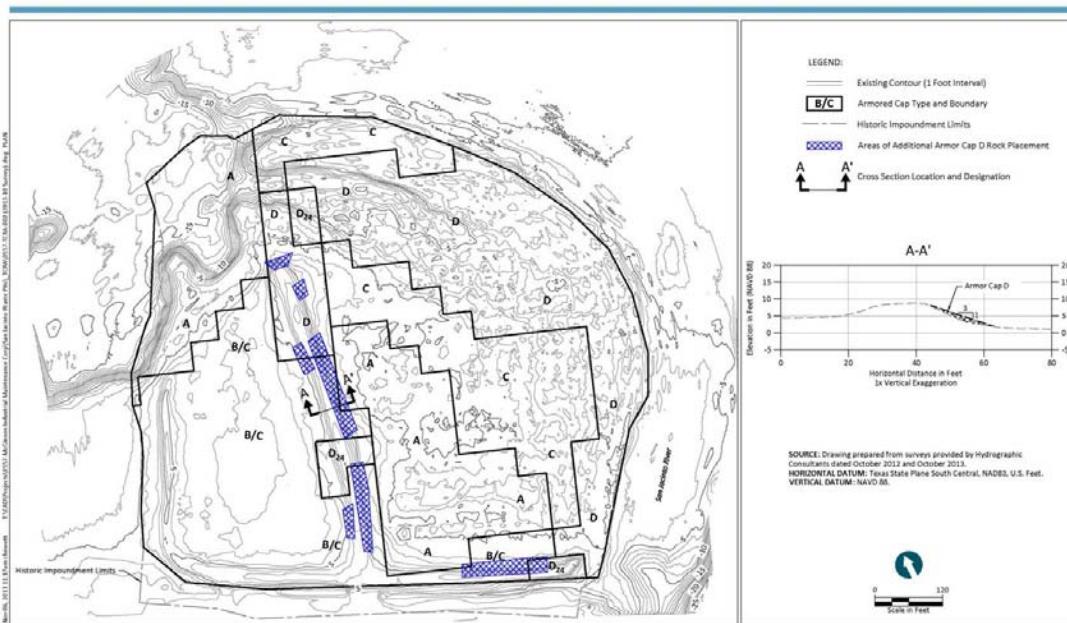
Figure 1  
Armor Cap Repair Plan  
San Jacinto River Waste Pits Superfund Site

In addition to inspecting the overall integrity of the armor cap, seven additional areas (see Figure One) were inspected where additional rock was placed and the slopes flattened to provide more stability and strength per the enhancement work plan dated November 2013. The section of the armor cap located above water level was also observed to be intact with no areas of cap erosion evident.

Figure 1- Areas to be covered with additional rock and flatten slopes from November 2013 Armor Cap Enhancement plan

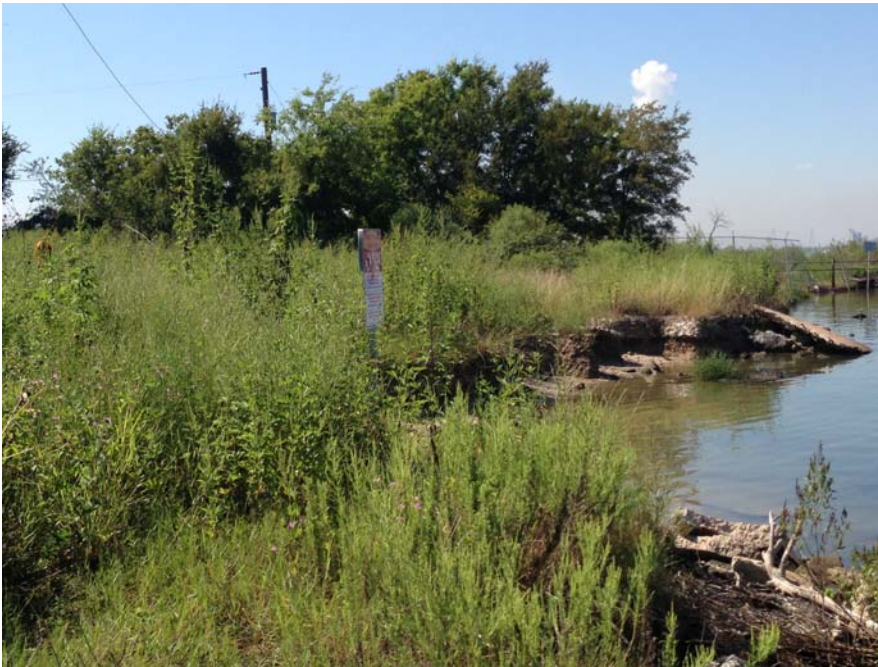
On January 30, 2013, EPA OSC Leos conducted a site visit to document observations at the San Jacinto River Waste Pits superfund site. During the site visit it was noted that the Site security fencing visible and intact. Site signage placed along the fencing perimeter was visible and intact.

Photo 1- View of Site signage surrounded by vegetative growth South of IH-10 along Eastern bank of San Jacinto River

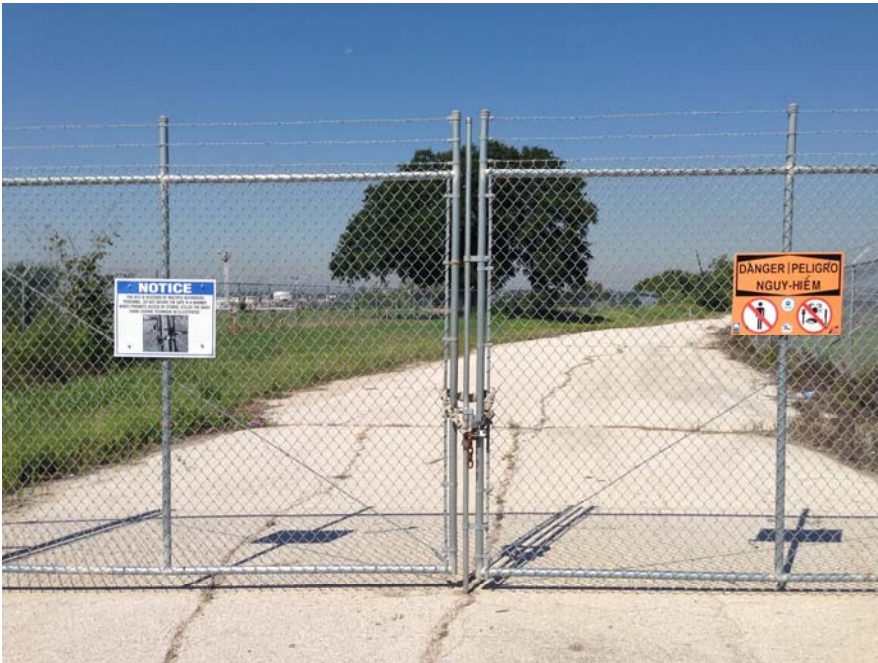
Photo 2- View of Site perimeter fencing East Gate along IH-10, East of San Jacinto River

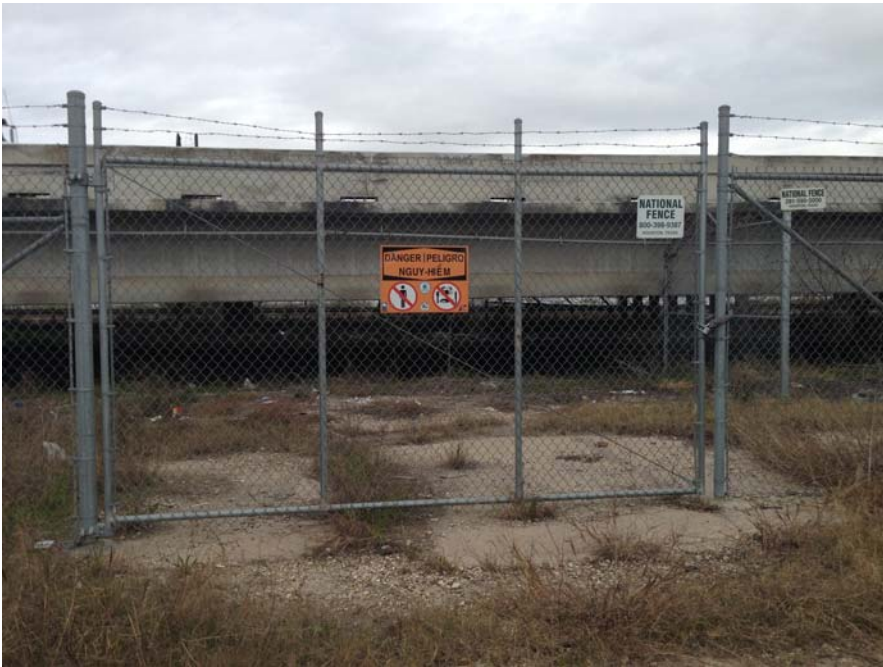
Photo 3- View of Site perimeter fencing Southern Gate, West of San Jacinto River

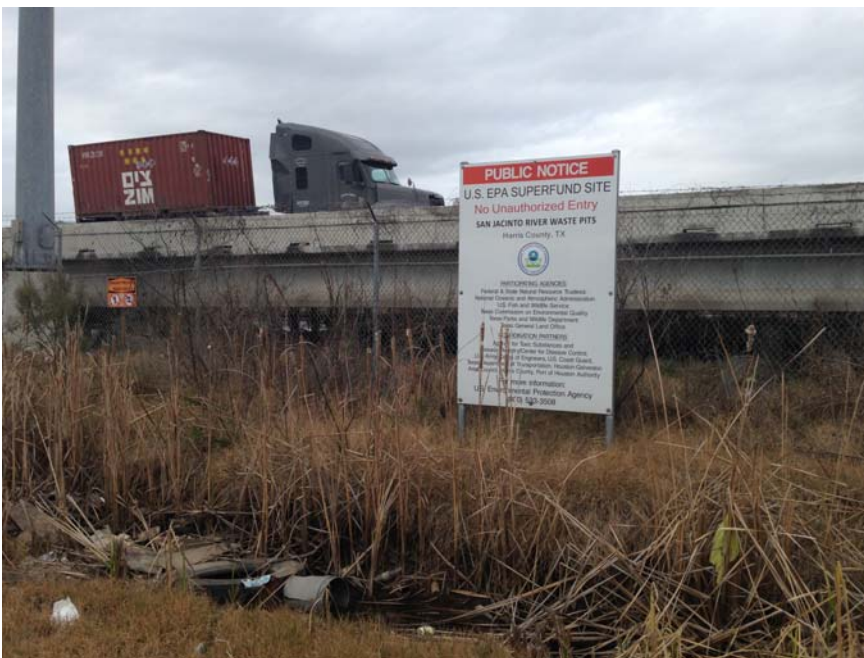
Photo 4- Picture of Site signage with vegetative growth from street level along fencing South of IH-10 near southern gate

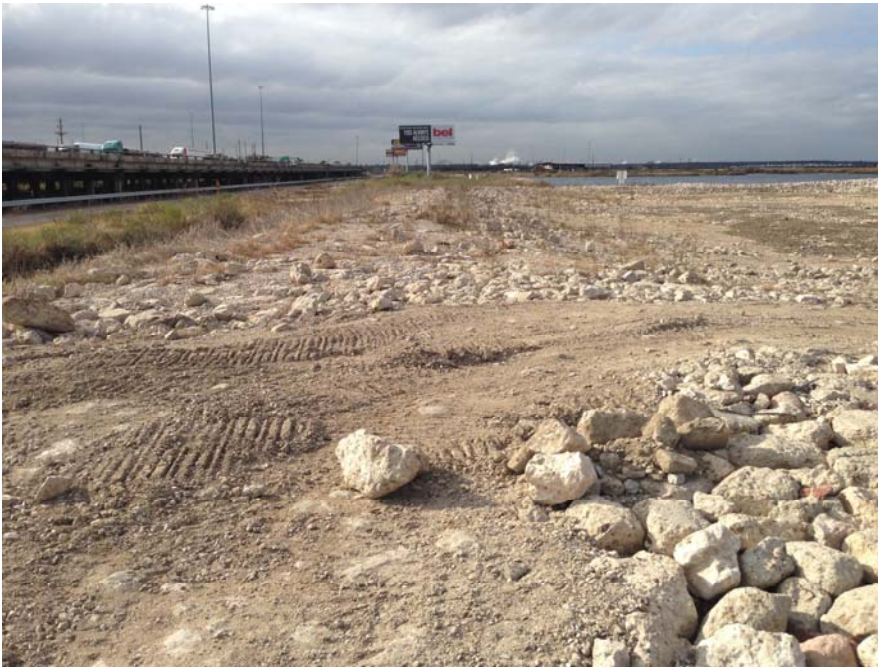
Photo 5- View of southern berm west of central berm.

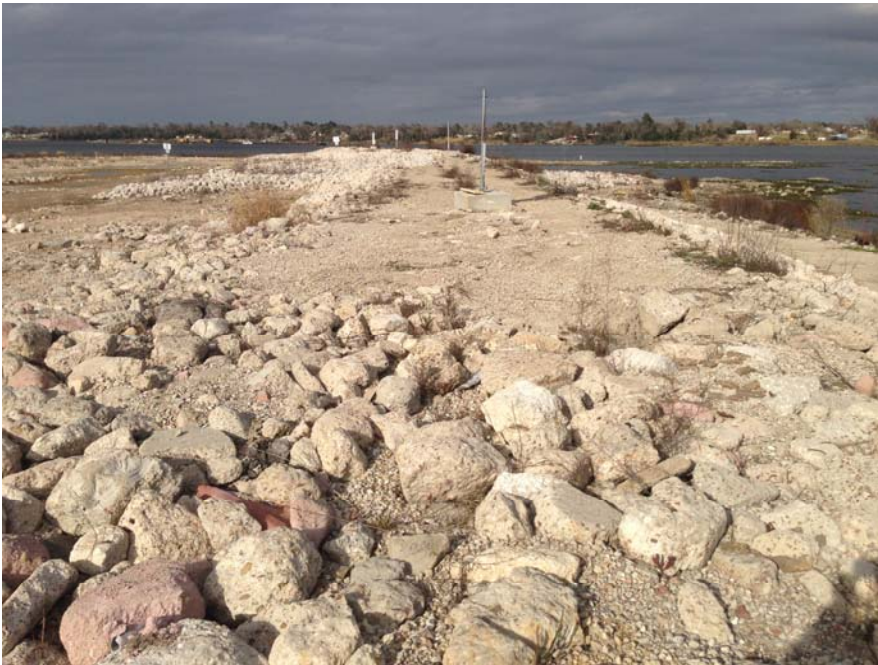
Photo 6- View of central berm

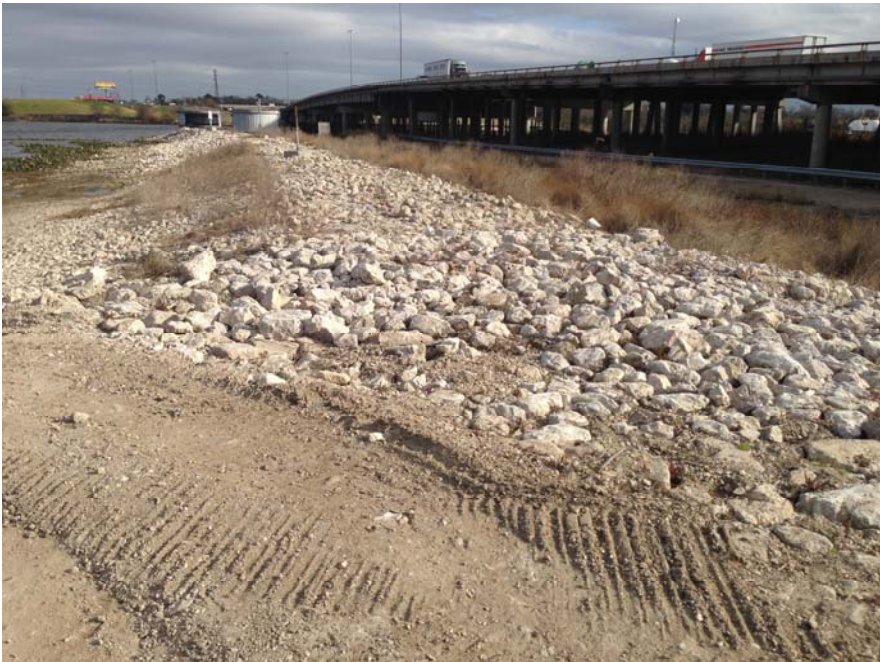
Photo 7- View of southern berm east of central berm.

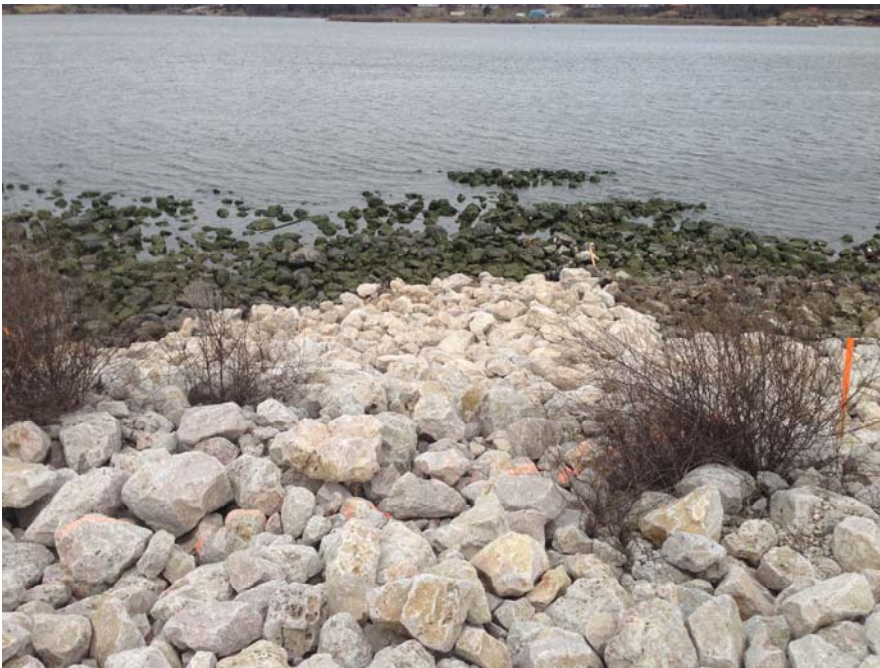
Photo 8- View of additional rock placed in area along central berm's northern edge

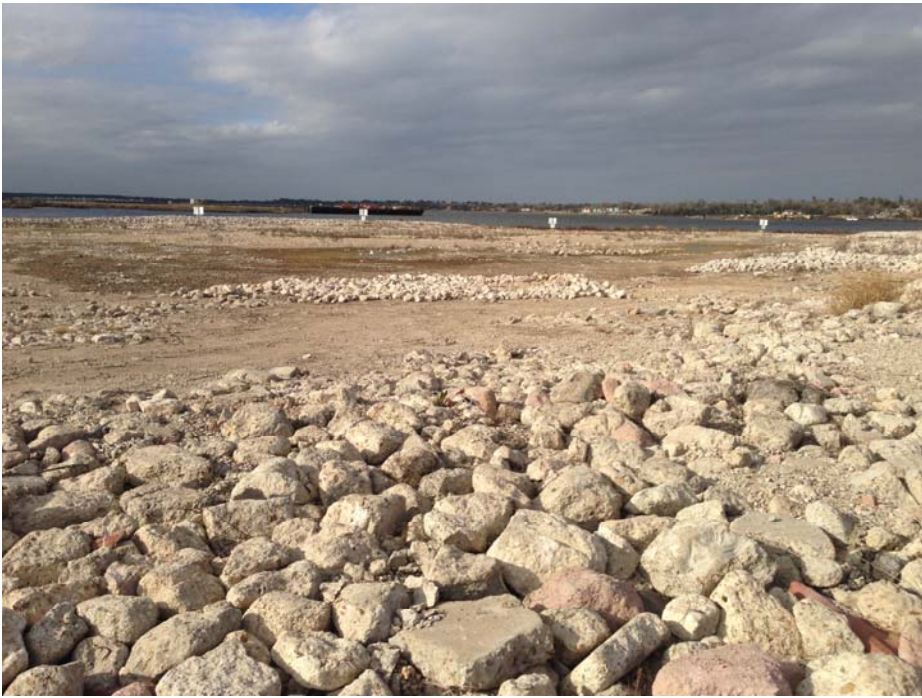
Photo 9- View of additional rock placed in area along central berm's southern edge
